CC was used to repair an eroded culvert located in an environmentally sensitive fish habitat

In November 2014, Concrete Canvas® (CC) GCCM was specified to reline a steel corrugated culvert pipe in Lewis County, Washington, USA. The material was supplied by Concrete Canvas Ltd's sales and distribution partner, Nuna Innovation Inc. who brand the material as Concrete Cloth.

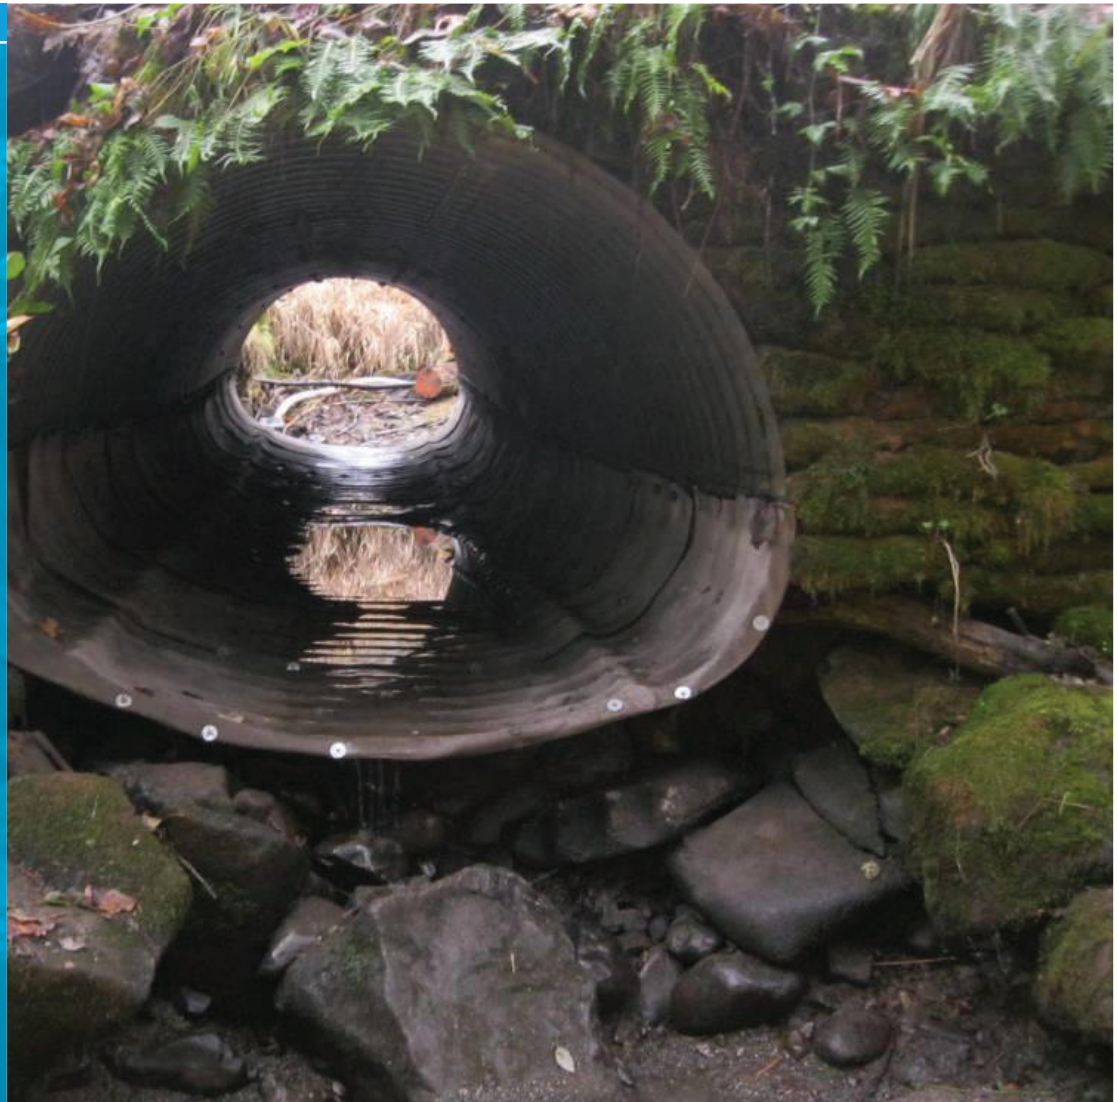
Completed culvert

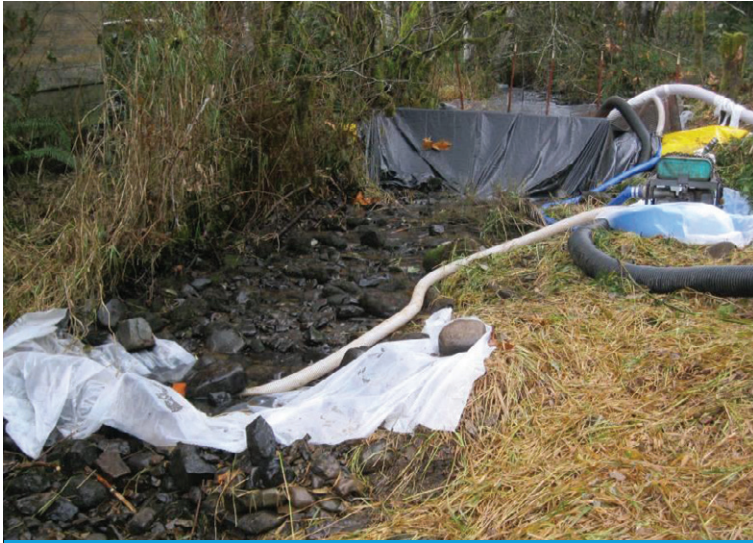
Isolating with cofferdams

To facilitate installation, a stream bypass was installed to divert water around the work zone. The work zone was then isolated with cofferdams while a fish rescue was performed and the site de-watered. Sediment laden water was pumped downstream to a grassy area where water was filtered prior to rejoining the stream channel.

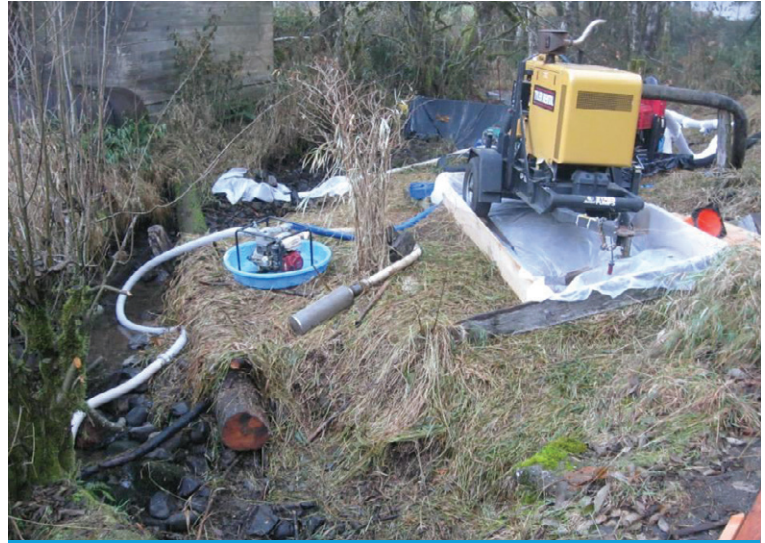
De-watering site

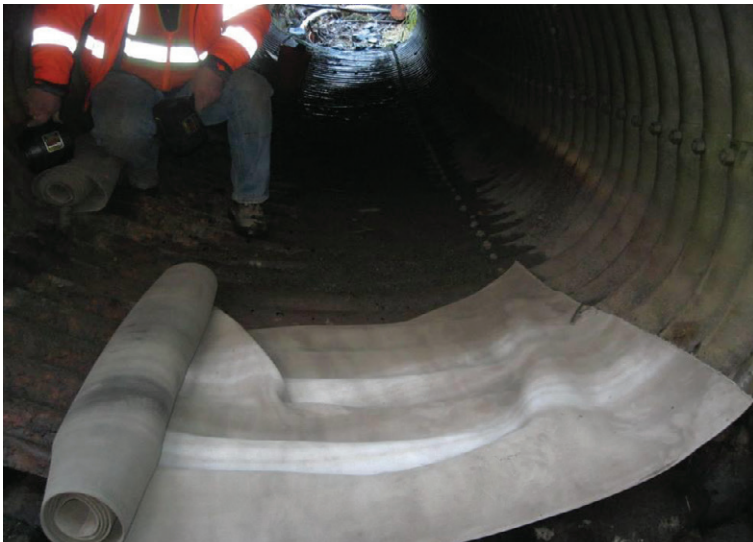
CC laid transversely across culvert floor

The CC lining covered an area of approximately 10ft wide and 34ft long. A minimum overlap of 4 inches (approximately 100mm) was given between layers. Self-tapping stainless steel screws were used to fix the CC to the culvert, placed approximately every 4 inches (100mm) along the sides of the culvert, and every 18 inches (approximately 450mm) along the culvert floor. The use of the caulk to seal the CC edges prevented any ingress and protected the edges of the material, while offering an additional fixing method to secure the material in place. Tar was also applied over the edges to ensure a water tight seal. At the inlet and outlet of the culvert, CC was wrapped and fixed beneath the culvert pipe and substrate placed to fill existing voids.

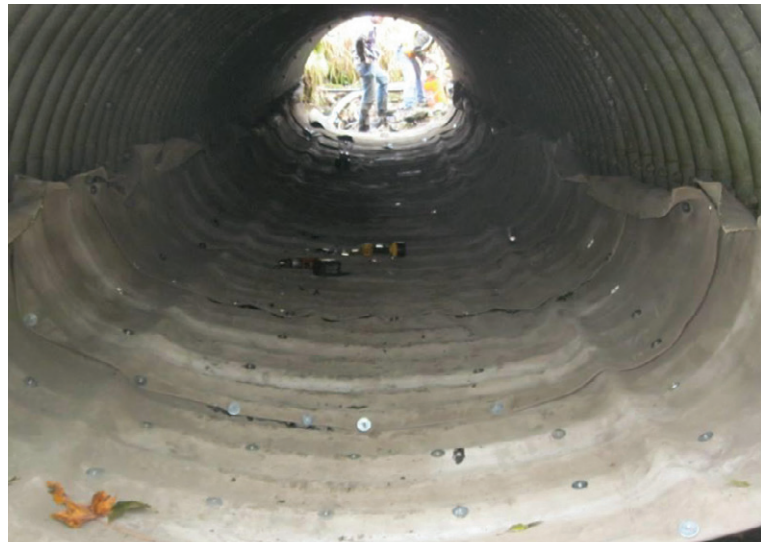
CC post-installation, prior to trimming and sealing of edges

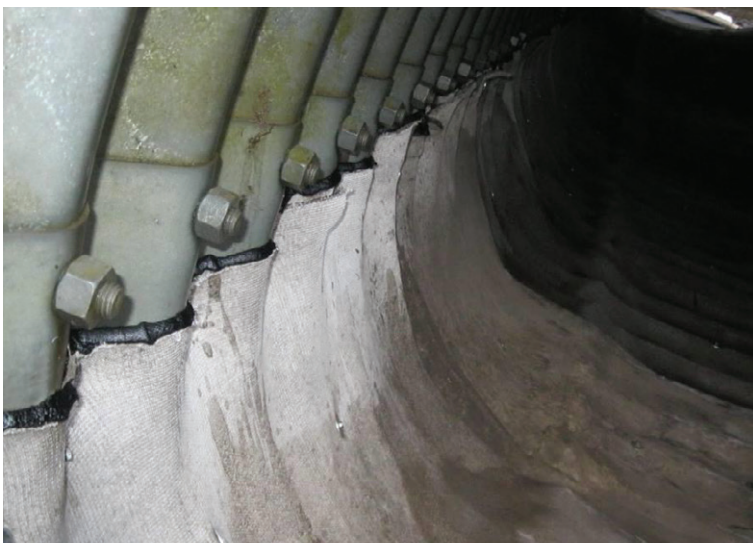
Tar used to seal material edges

The installation was completed over two days; the first day, the crew of five workers installed the CC, before hydrating it and leaving it overnight to set. On the second day, the CC edges were sealed using caulk.

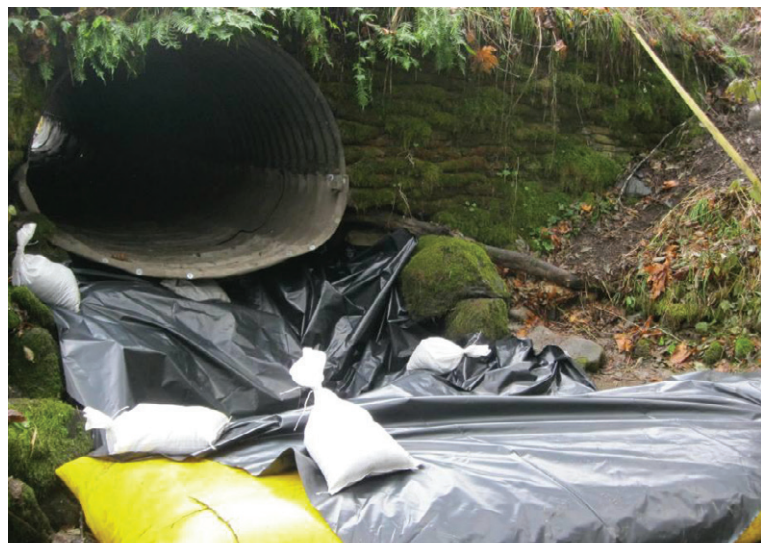
Water catchment for pH testing

Once installation was completed, pH monitoring was carried out as water was introduced to the material for hydration. Any excess water in the work zone was pumped to an upland where it would infiltrate. Once the CC had hardened, the water was pumped through the culvert, tested, and pumped to an upland until pH readings were within 0.5 units of the background readings between 6.5 and 8.5 units. Once complete and pH readings met the required levels, the cofferdams were removed and the stream allowed to flow freely.

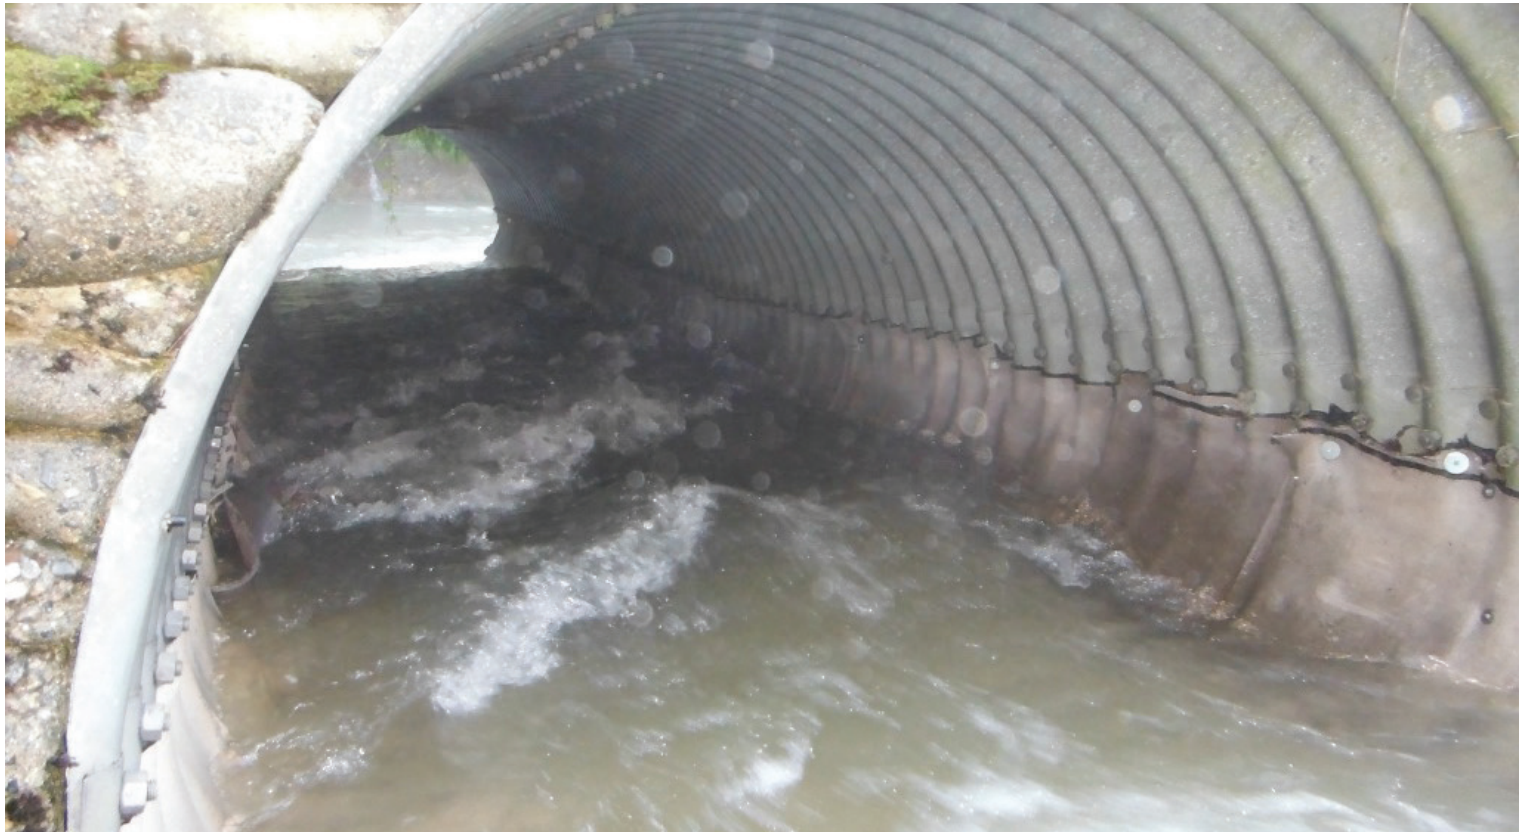
Site re-visited in January 2015

The client was pleased with the installation, noting that the CC was delivered on time and well-packaged. Workers were trained on-site and the project ran smoothly. After numerous high-flow events during the months following the completion of the project, the CC was still performing as designed. Overall, Lewis County rates the project a success.
