CASE STUDY

Concrete Water Holding Cell-HDPE Geomembrane

- ▼ **LOCATION:** Undisclosed
- ▼ **PROJECT TYPE:** Supply and installation
- ▼ **PRODUCT USED:** 60 mil HDPE geomembrane liner

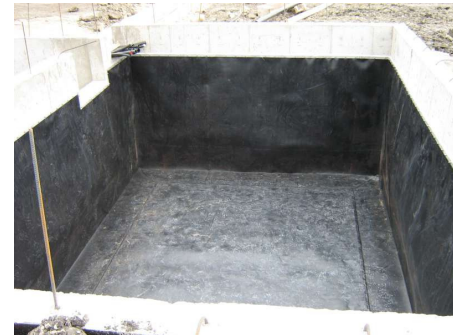
Provide a solution for a leaking concrete water holding cell.

The project highlights a custom fit liner for a concrete water holding cell. This cell had been in service for quite some time and had developed leaks due to concrete aging which threatened contamination and the tank's continued use. To address this Titan installed a 60 mil HDPE geomembrane liner which would protect the concrete cell from leaking, prevent water contamination and ensure water potability. This particular cell was located right beside a power room. This meant that there had to be a zero leak factor which was achieved by negative air pressure testing, utilizing an ultrasonic listening device to detect any deficiencies in the liner before it could be filled. This solution helped prolong the cell's life span and provided the owner with a cost effective alternative to replacement. Additionally lining the cell helped protect and minimize any corrosion of the structural rebar.
