CASE STUDY

Mine Polishing Pond and Ditch

- ▼ **LOCATION:** Northern, B.C.
- ▼ **PROJECT TYPE:** Multi-layer lining system
- ▼ **PRODUCT USED:** HDPE Liner, Non-woven Geotextile and Geocomposite

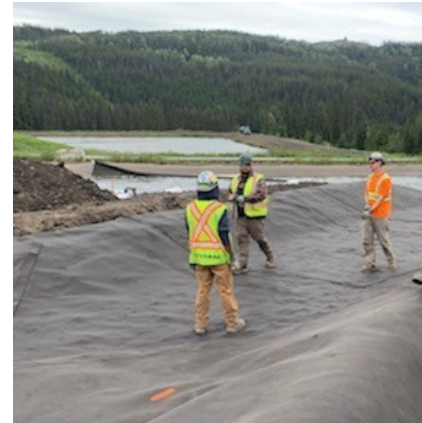
A biochemical reactor polishing pond and adjacent ditch at a remote mine site in Northern B.C. needed lining for proper containment of liquid contaminants

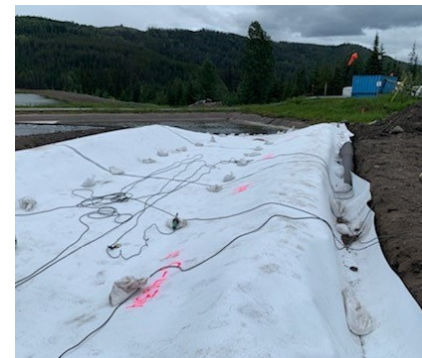
Titan supplied and installed 16oz geocomposite as a drainage layer, followed by a layer of 32oz nonwoven geotextile cushion and a layer of 60mil DST White HDPE geomembrane specified in the engineered design.

We were chosen for this project due to our extensive lining system installation experience and our ability to quickly adapt and overcome any installation challenges. The entire install took a total of 5 days to complete. We worked with the client, project engineers, and our field/operations to solve general constructability issues and redesign a pipe penetration.
