## CHANNEL LINING

In September 2014, Concrete Canvas<sup>®</sup> (CC8<sup>™</sup> - GCCM) was specified as a channel lining solution in a trial application on Gully Road, intersecting the Takhini River road in Whitehorse, Yukon, the smallest territory in Canada, located in the north-west of the country.

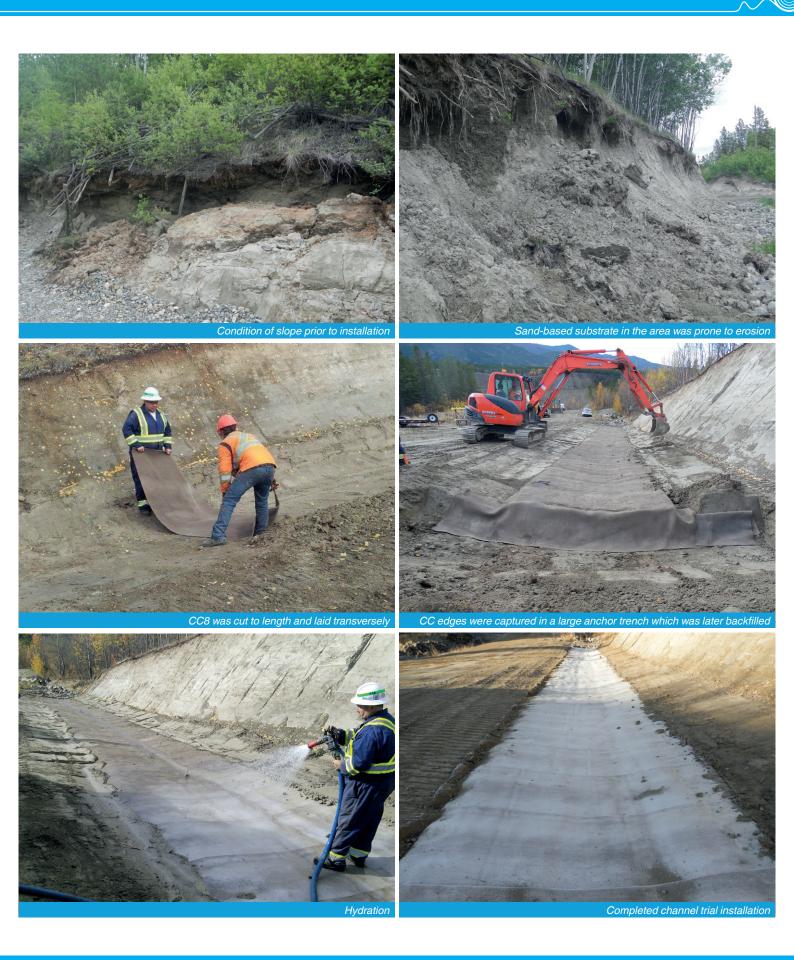
An area was selected to install and observe the overall suitability and performance of the CC during melt conditions. In preparation for the installation, vegetation was removed from the substrate and the slope re-graded to 1:1. The channel was then re-profiled. The CC was deployed using a transverse layup with a 100mm overlap in the direction of flow. Overlapped lengths of the CC were jointed with 22mm screws at intervals of 300mm. The outside edges of the material were captured in an anchor trench and fixed using spikes.

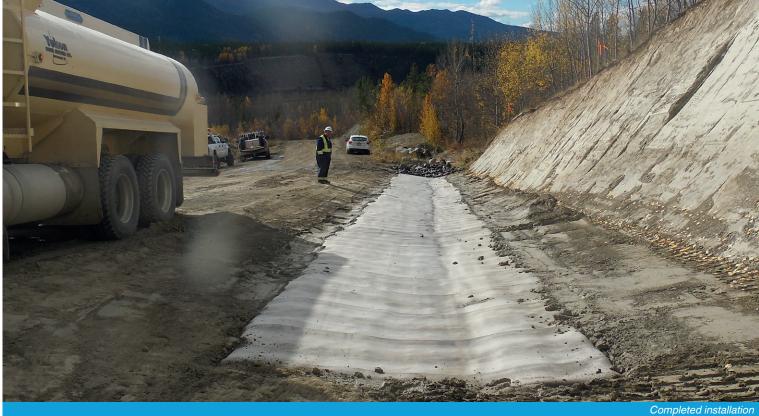
The project was completed by a team of three in just 8 hours. Since installation, the client has observed no migration or damage to the CC and no undermining or erosion of the substrate below. Water is travelling within the confines of the lined portion of the channel as designed.
