In July of 2016, 50 sq. m of Concrete Canvas 8mm (CC8) was used to line 8 outfalls on the side slope of a roadway in Saskatoon, SK, Canada. Each outfall was approximately 1m wide and 6 m long.

CHANNEL LINING

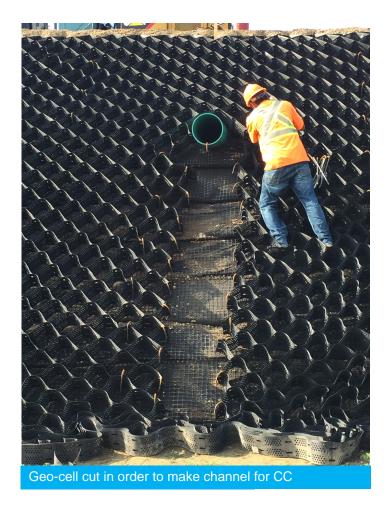
Channels filled with sand

The channel, along with the Geo-Cell on either side of the channel, was filled with sand and compacted to prevent any voids underneath the CC. Plywood was also utilized along the sides of the channel to provide a smooth transition from the channel to the Geo-Cell.

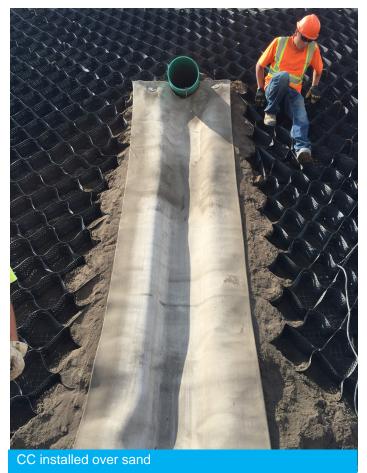
Hydration of completed CC installation

One layer of CC8 was installed longitudinally down the channel beginning directly underneath the outfall pipe. It was fixed to the substrate every meter along each side of the channel using earth percussion anchors. Hydration was achieved using a 275 gallon tote with a 2" pump.
