CULVERT LINING

Summer 2019

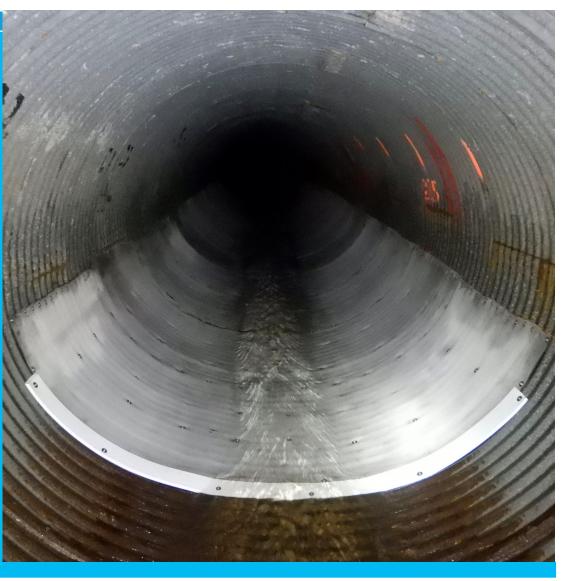
In 2019, Concrete Canvas® (CC8) was used for the rehabilitation of an existing 2,100mm diameter, structural plate corrugated steel pipe approximately 372m in length at the Mackinnon Ravine storm trunk near 149th street in Edmonton, AB. Existing deficiencies in the culvert storm trunk included high ovality deformation, invent corrosion and joint separation.

Titan supplied batched rolls of Concrete Canvas® (CC8). This, which was the preferred choice for this project due to its ease of installation, cost effectiveness and ultimately because it allowed for the existing culvert to be re - used, saving the client money and time. Replacing the entire culvert would have been more costly and labor intensive. The CC8 was utilized as a hybrid solution to repair areas of invert corrosion and joint separation while areas of high ovality were slip lined as a structural solution. The client chose Titan as the supplier for this project due to our quick product lead times, our focus on service and our vast knowledge of Concrete Canvas® culvert rehabilitation projects.
