BRIDGE REMEDIATION

In June 2017, CC Hydro[™] (CCH) GCCB^{*} was used to provide a waterproof layer to bridge decking on the Old Elvet Bridge in Durham, UK. The Old Elvet Bridge is a Grade I listed medieval masonry arch bridge across the River Wear, linking the peninsula in central Durham and the Elvet area of the city. Building of the bridge began in AD 1160, and construction of the arches is believed to have continued into the 13th century, although exactly how many there are is still debated to this day.**

ELVET BRIDGE

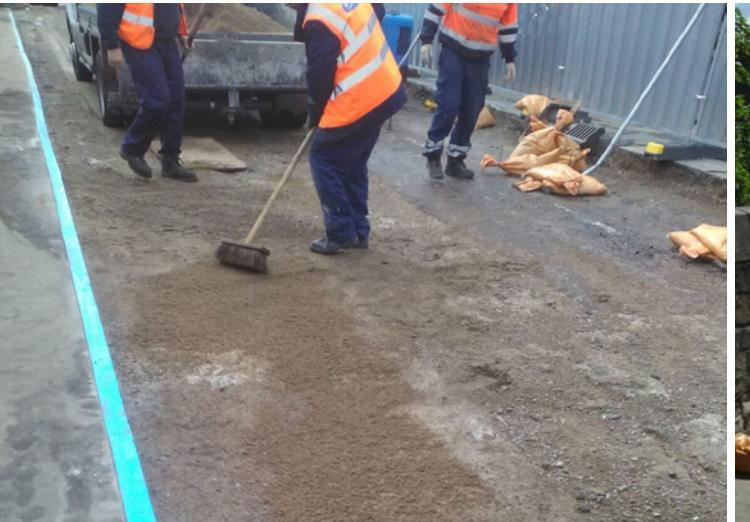
The substrate was flattened before installation

In preparation for the installation, the top flag stones were removed along with some of the substrate and the ground compacted using a whacker plate in order to provide a smooth surface for the CCH to be laid on. Bulk rolls of CCH8[™] were then delivered to DCC's warehouse and then delivered to the site when required. The bulk rolls were then mounted onto a spreader beam and unrolled longitudinally along the length of the bridge. Adjacent layers of CCH were laid and then thermally welded using a Leister Twinny T or Leister Triac and roller. Once laid and thermally welded, each section was hydrated and re-covered using the removed substrate, leaving the leading edge of the CCH uncovered to weld to the adjacent layer of the next section.

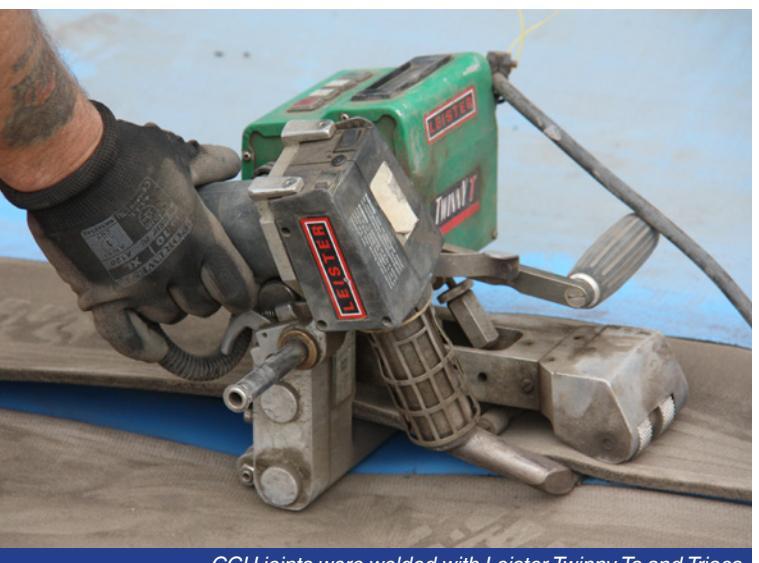
CCH joints were welded with Leister Twinny Ts and Triacs

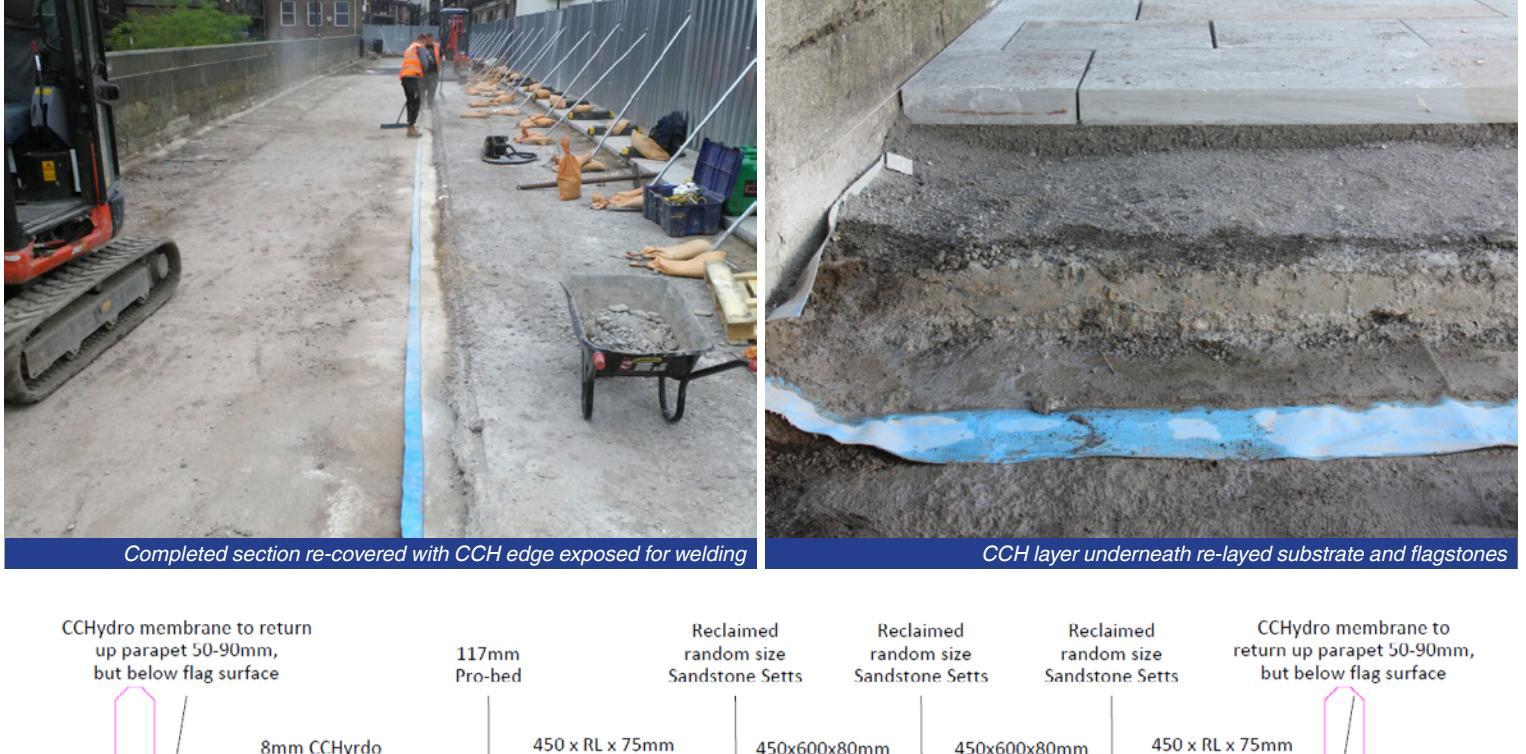
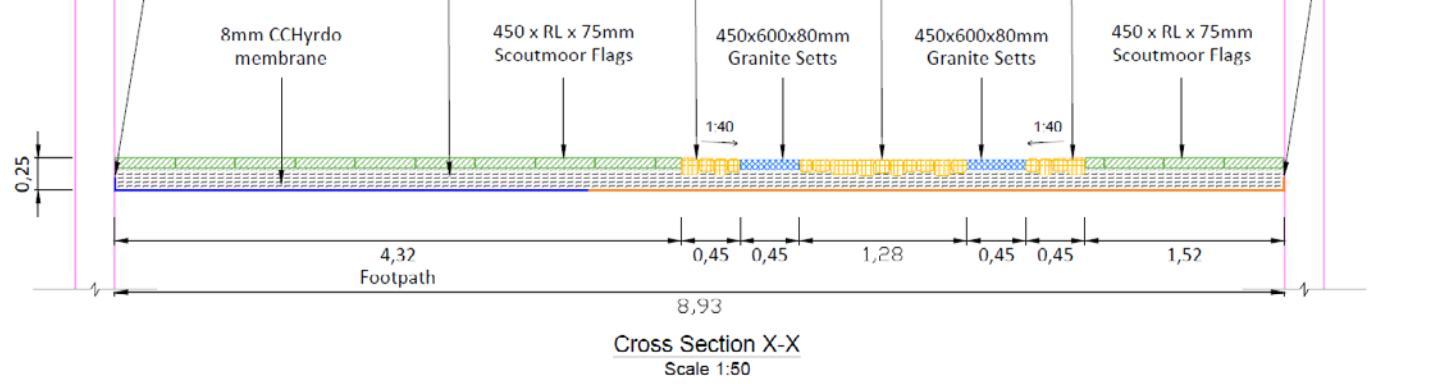
Cross Section Proposal Drawing

Following the installation of the CCH across all sections of the bridge, the flag stones were re-laid on top of the waterproof CCH layer.
