CC8™ Batched Rolls

Miller Capilano Highway Services

CC8™ was trialed to establish its suitability as a method of repair for damaged curbs in Canada

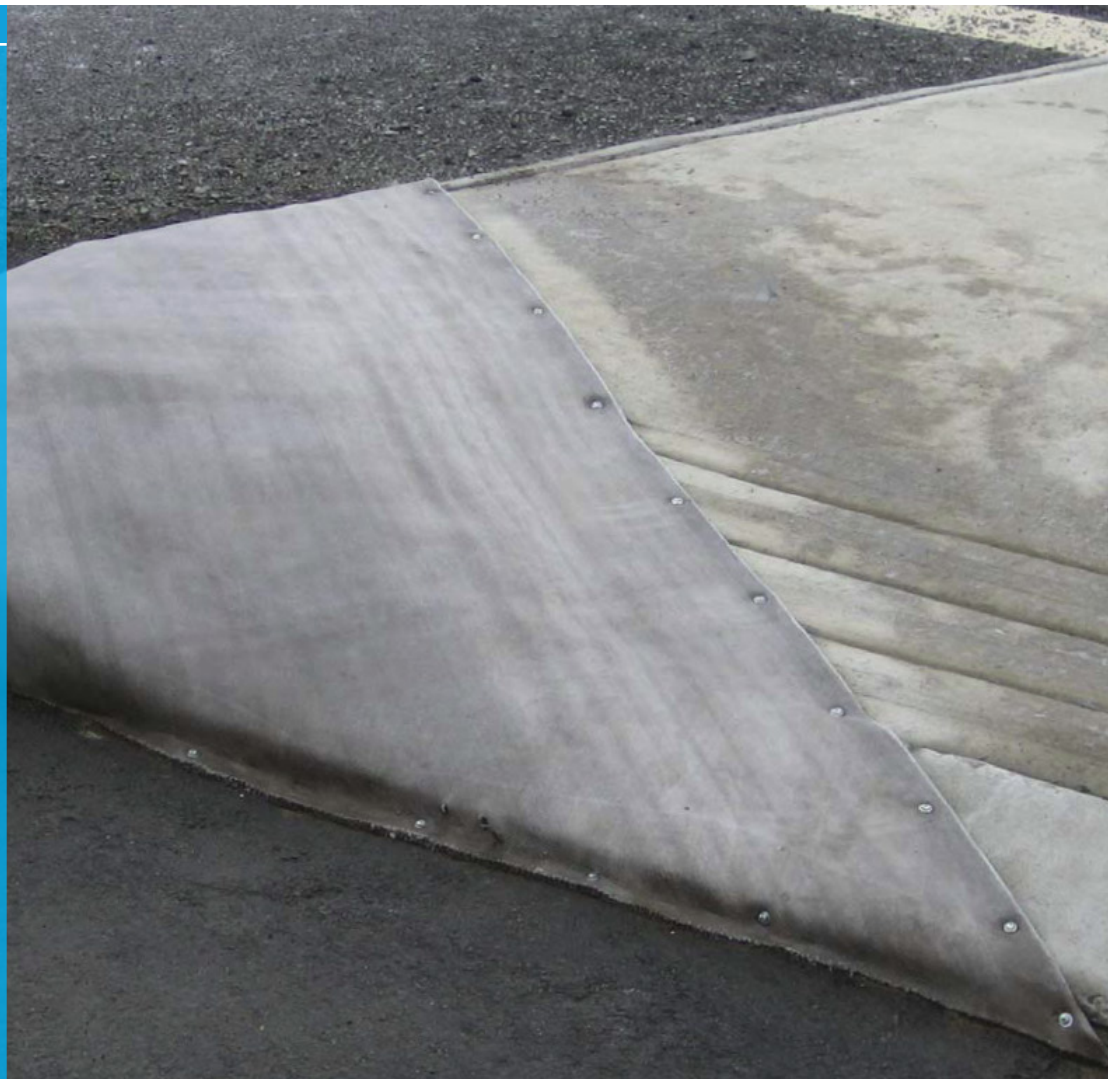
Completed installation

The void in the damaged curbs were first filled, before being lined with CC8™. The CC was first wrapped around the damaged curb areas, with some excess covering the undamaged pavement, and then fixed to the concrete pavement and remaining, undamaged curb surface using concrete anchor screws. The CC was then hydrated.

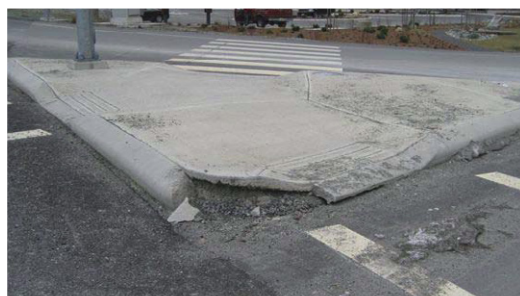
Damaged curb section at main junction

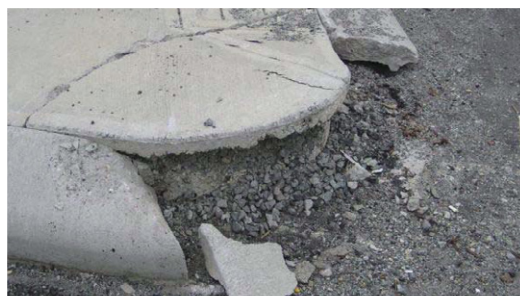
Close-up of damaged curb
