PROTECTING A NORTHERN MINE LEACHATE SPILLWAY WITH CONCRETE CANVAS

By **Ron Drewry, Phill Greer, Rebecca Spitzer** and **Chantal Lambert**

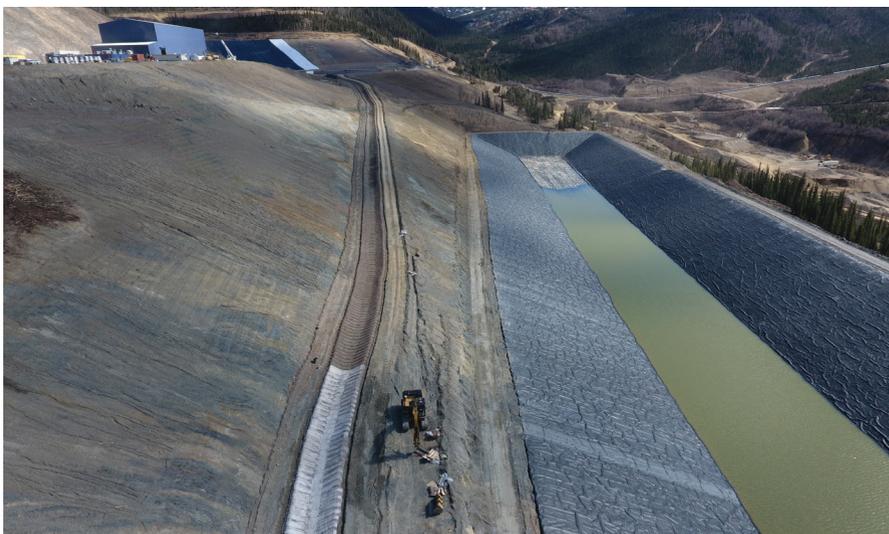
Left: The main spillway is approximately 500 m in length. The spillways were designed to convey any overtopped heap leachate in case of extreme weather events. **Right:** The secondary emergency spillway is approximately 140 m in length of varying width at 50% gradient.

The main spillway is approximately 500 m long with profile sections of 5 – 8 m at a 7% – 15% gradient. In this spillway, CC8 (8 mm thickness) was used for fall sections of 7.5% and CC13 (13 mm thickness) was used where the fall of the section increased to 15%. Installation was completed per standard channel lining details: hydrated overlaps, Soudseal 250XF bead, SS screws at 200 mm centres, 100-150 mm overlap with a 1.3 m anchor trench (0.75 x 3) along either crest with ground pins. Intermediate fixings were not required.
