SLOPE PROTECTION

In January 2017, Concrete Canvas® GCCM* (CC), branded Concrete Cloth™ in the US, was used to provide slope protection in Rossville, TN in the USA.

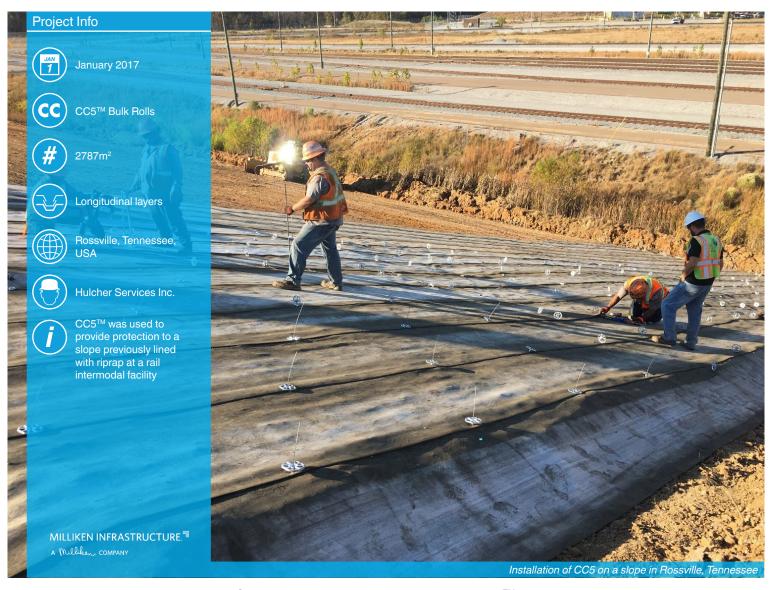
CC5 was specified for the project and was delivered to the site in bulk rolls. The material was laid longitudinally down the slope, from crest to toe. Subsequent layers of CC were overlapped by 100mm and jointed using percussion earth anchors, which were also used to fix the material edges. The edges were then captured in anchor trenches prior to backfilling.

In total, approximately 2787m² of CC5™ were installed at rates of around 557m² per day. To this date, the client is very pleased with the installation and has acknowledged CC as a viable option for use in future projects.
