## CHANNEL LINING

In August of 2013, the City of Vaughan's Public Works department in Vaughan, Ontario installed 90 sq. meters of CC5 batched into one of the cities water diversion ditches. Prior to installation the ditch had been over grown with vegetation and proper water run off was difficult. Concrete Canvas was chosen due to its benefits of rapid installation time and maintenance cost savings over time.

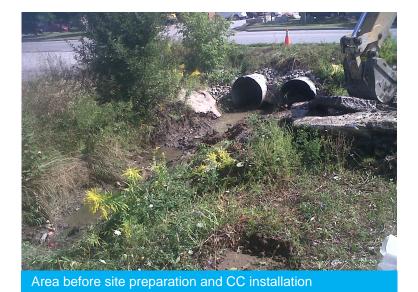
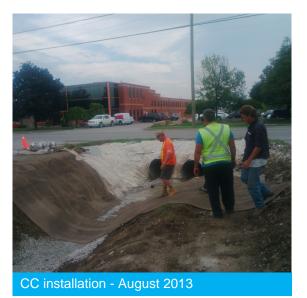
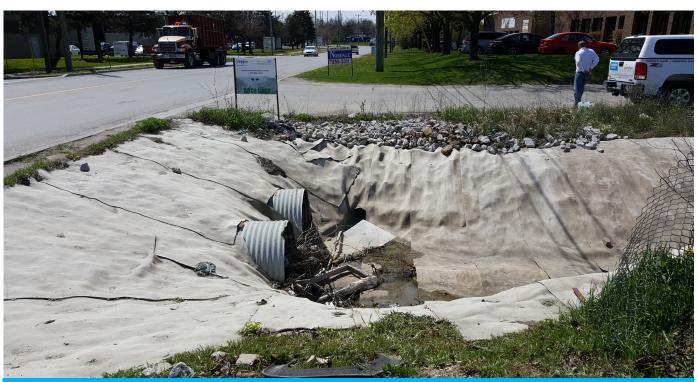
36 months after the installation took place, the Concrete Canvas (CC) lined ditch is holding strong. Vegetation has grown back along each side of the ditch with no growth present inside the ditch itself. The CC has weathered very well with no visible changes. Some debris as been getting caught on the culverts entrances but this has not effected the CC's integrity. Since this CC installation, the customer has completed several other CC projects.

36 months after installation CC is holding strong with no vegetation growth
